# Visual Consequences of Greater Hood Heights in Larger Passenger Vehicles

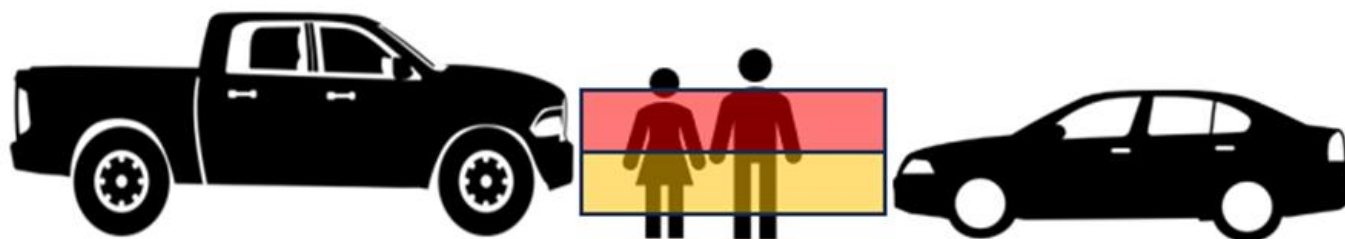
Pedestrian impact area for tall pickup

Pedestrian impact area for average sedan

Blind spot for tall pickup

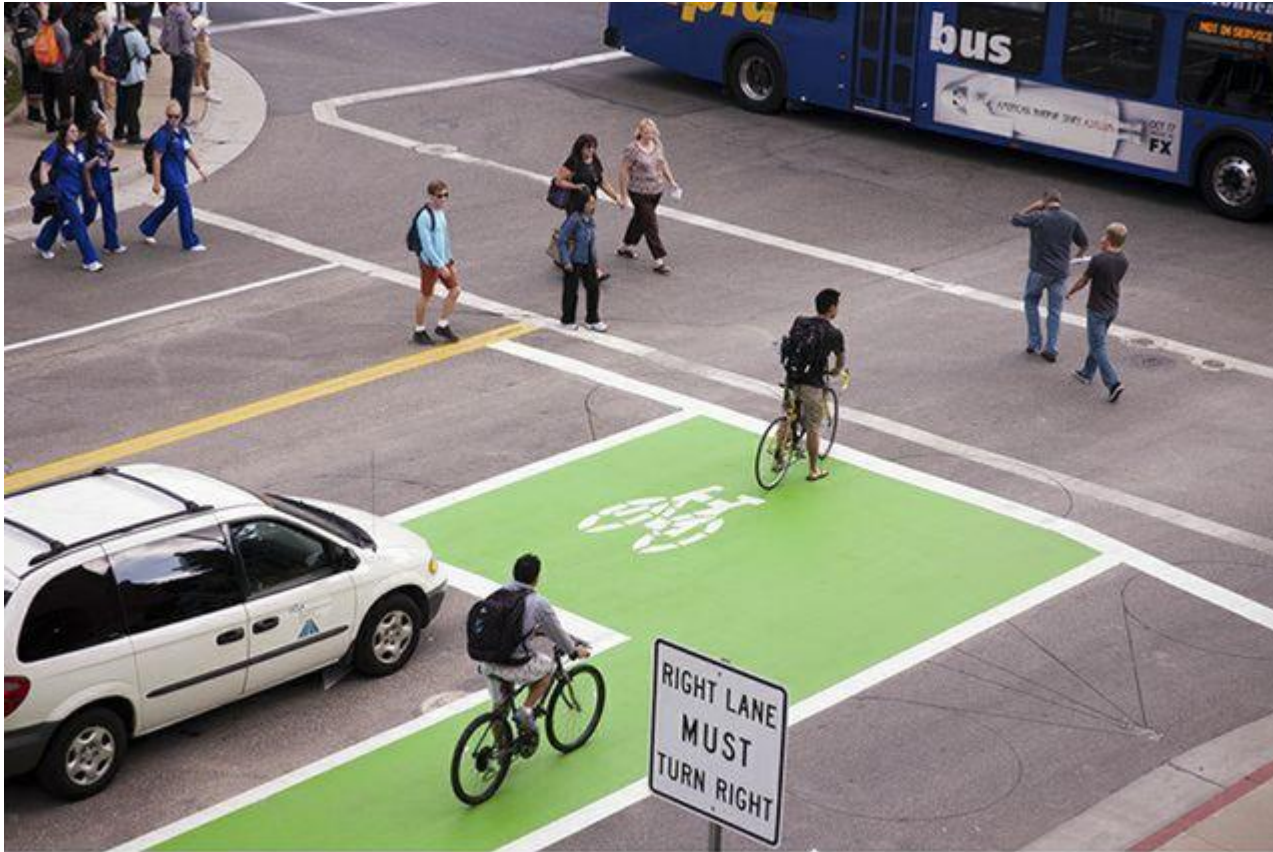
## Bike box

- Space for cyclists to position ahead of vehicles

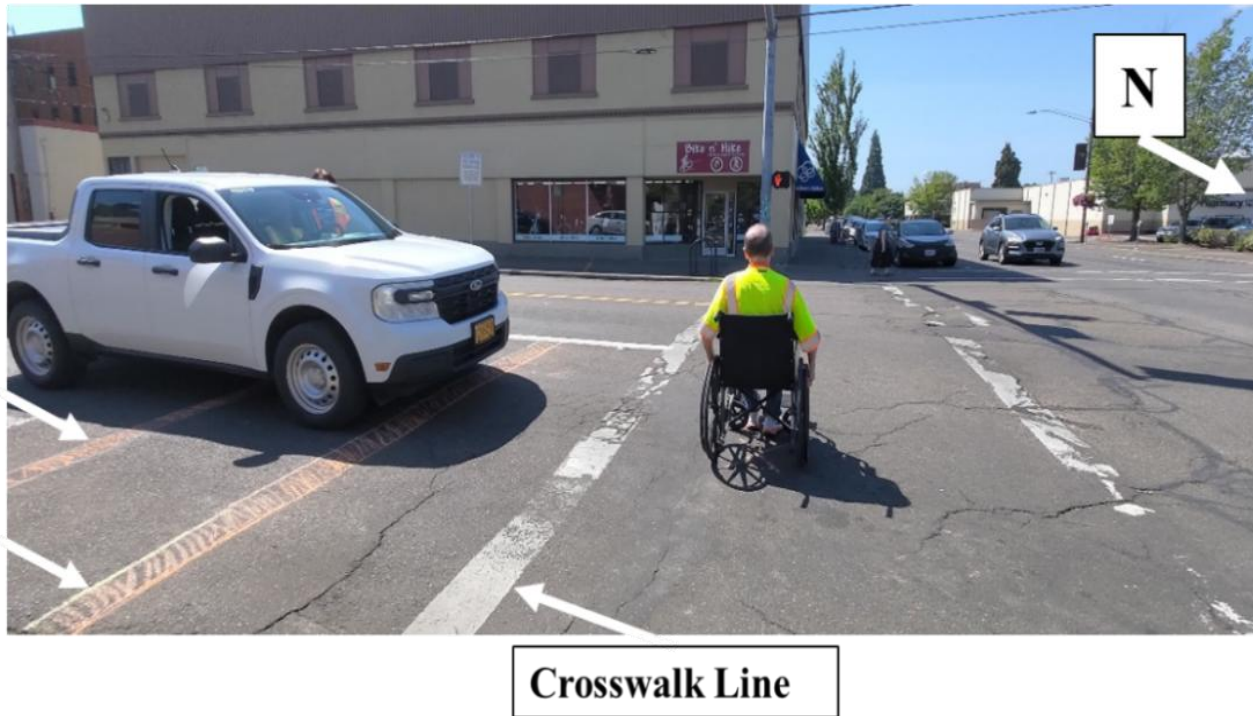
- 0 foot setback - manually placed at crosswalk line
- Other 3 positions – natural stop (about 2-5 ft behind the line)

Driver stopped at crosswalk position  
(note 2-5 ft back)

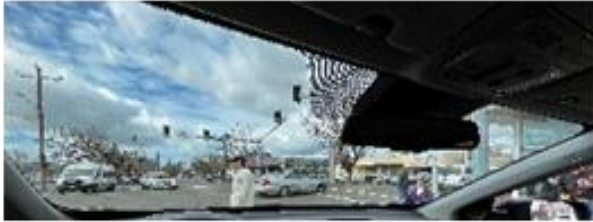
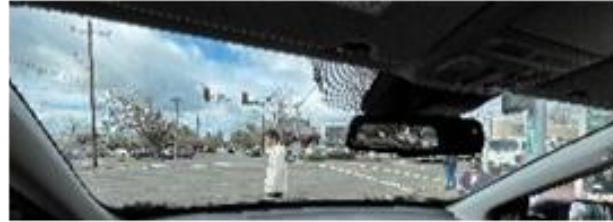
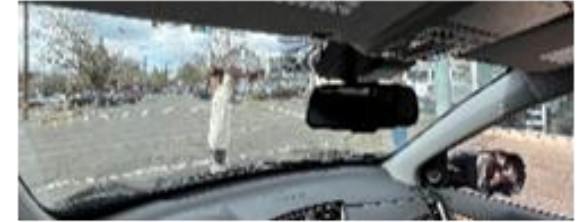
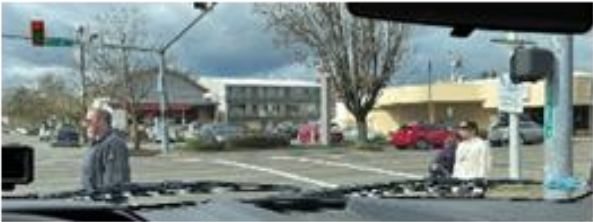
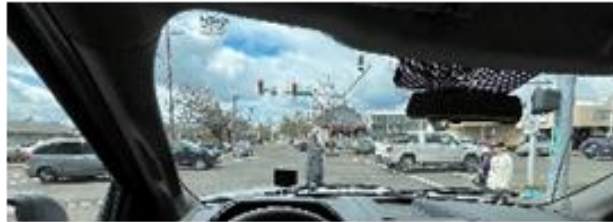
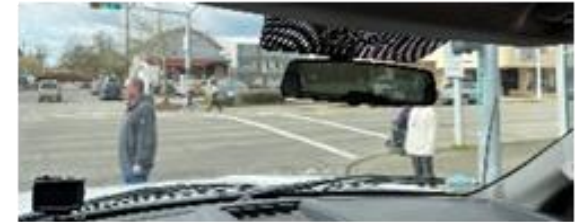
Phone held up to eye of driver

**Honda  
CRV -  
Crosswalk**

**Ford  
Maverick –  
0 ft Setback**

**Ford F250  
– 10 ft  
Setback**

**Shorter Driver  
(5')**

**Average Driver  
(5' 10")**

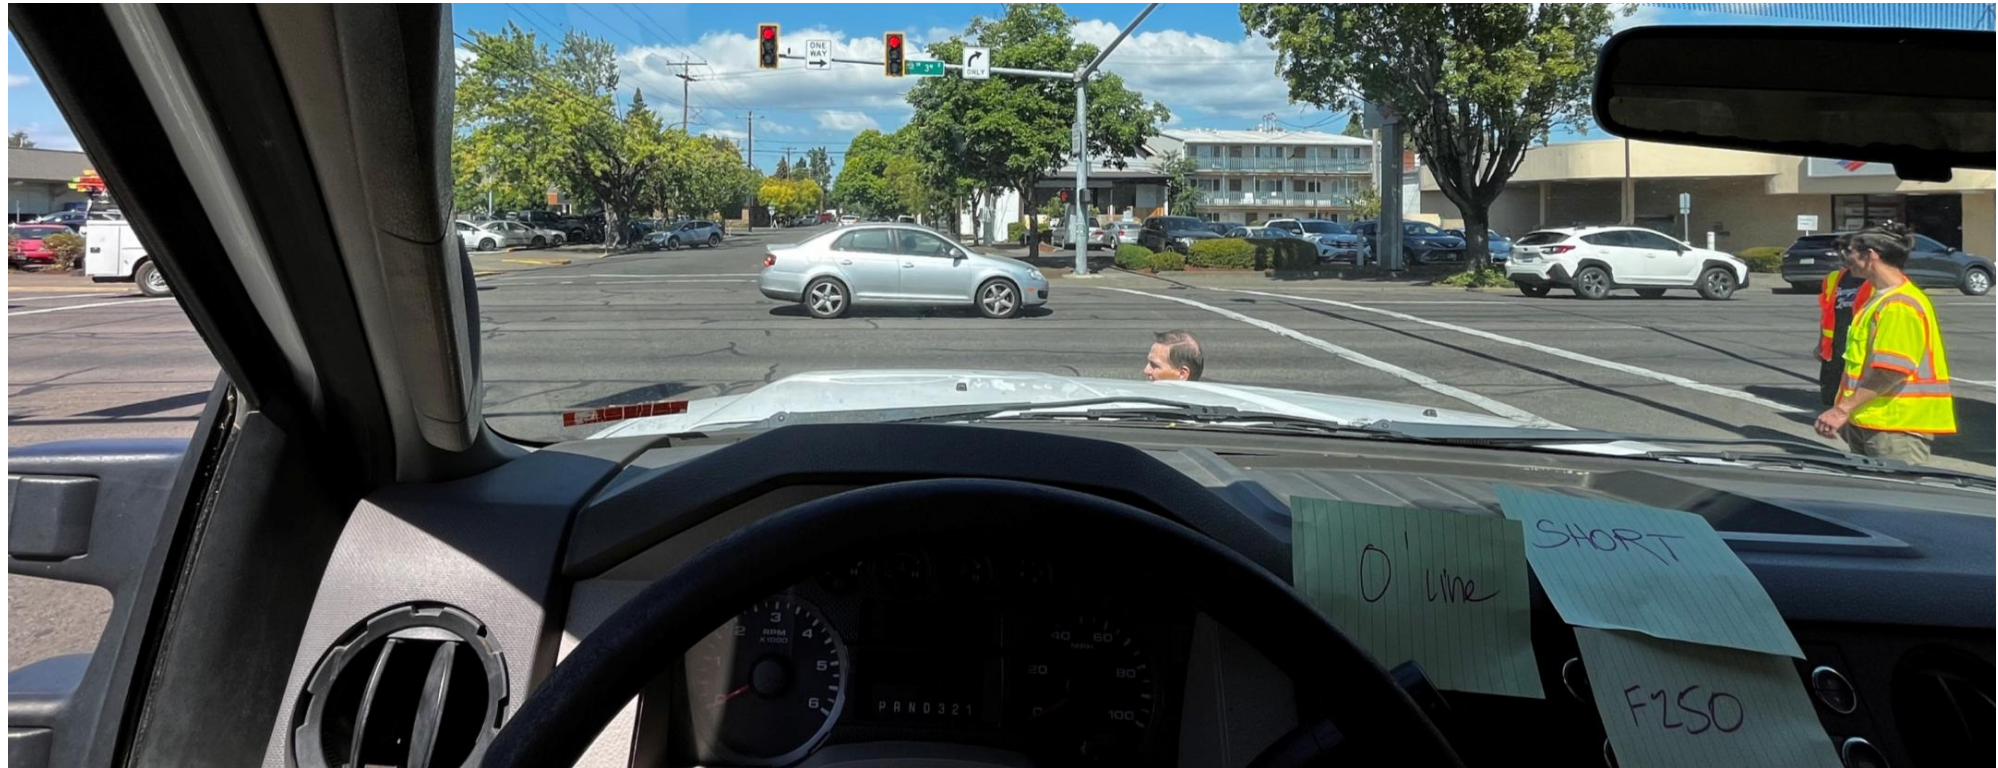
Short driver (60 in)

Vehicle positioned at Zero Setback

Pedestrians in all 3 positions,  
wheelchair in crosswalk

F250 vehicle (52 in hood height)

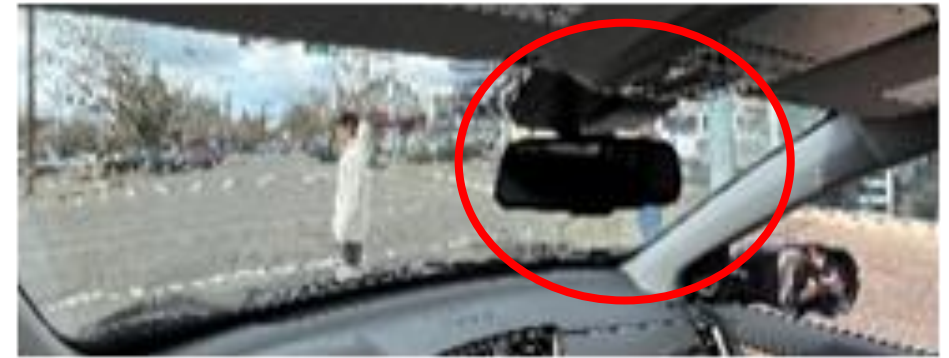
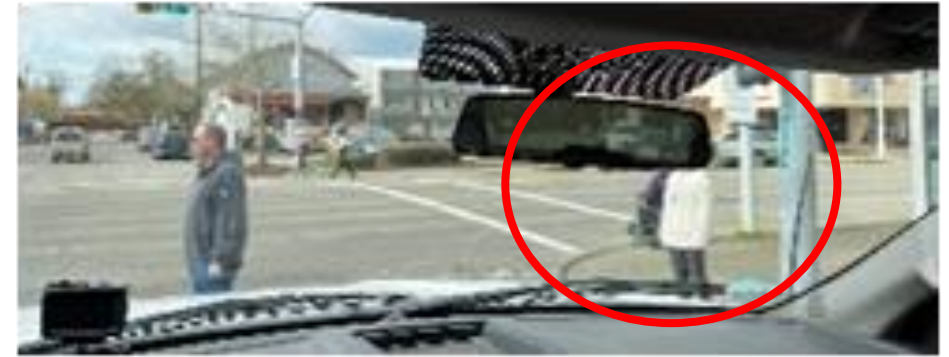
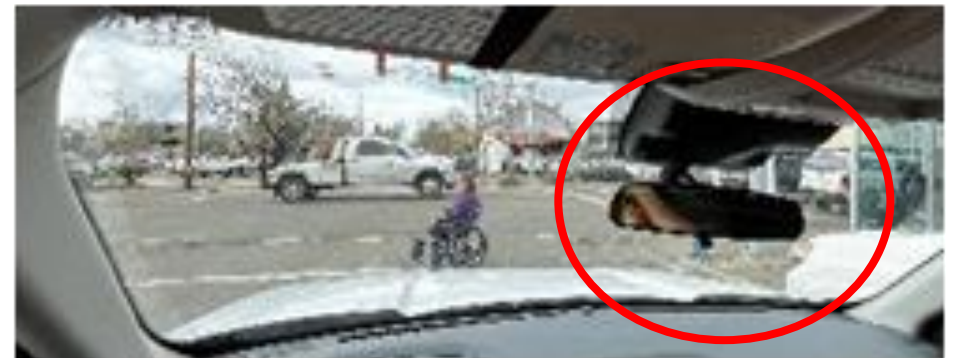
Rearview mirror  
Sensor assembly  
Other pedestrians on the corner

Obstruction-less data presented  
to solely analyze variables of interest

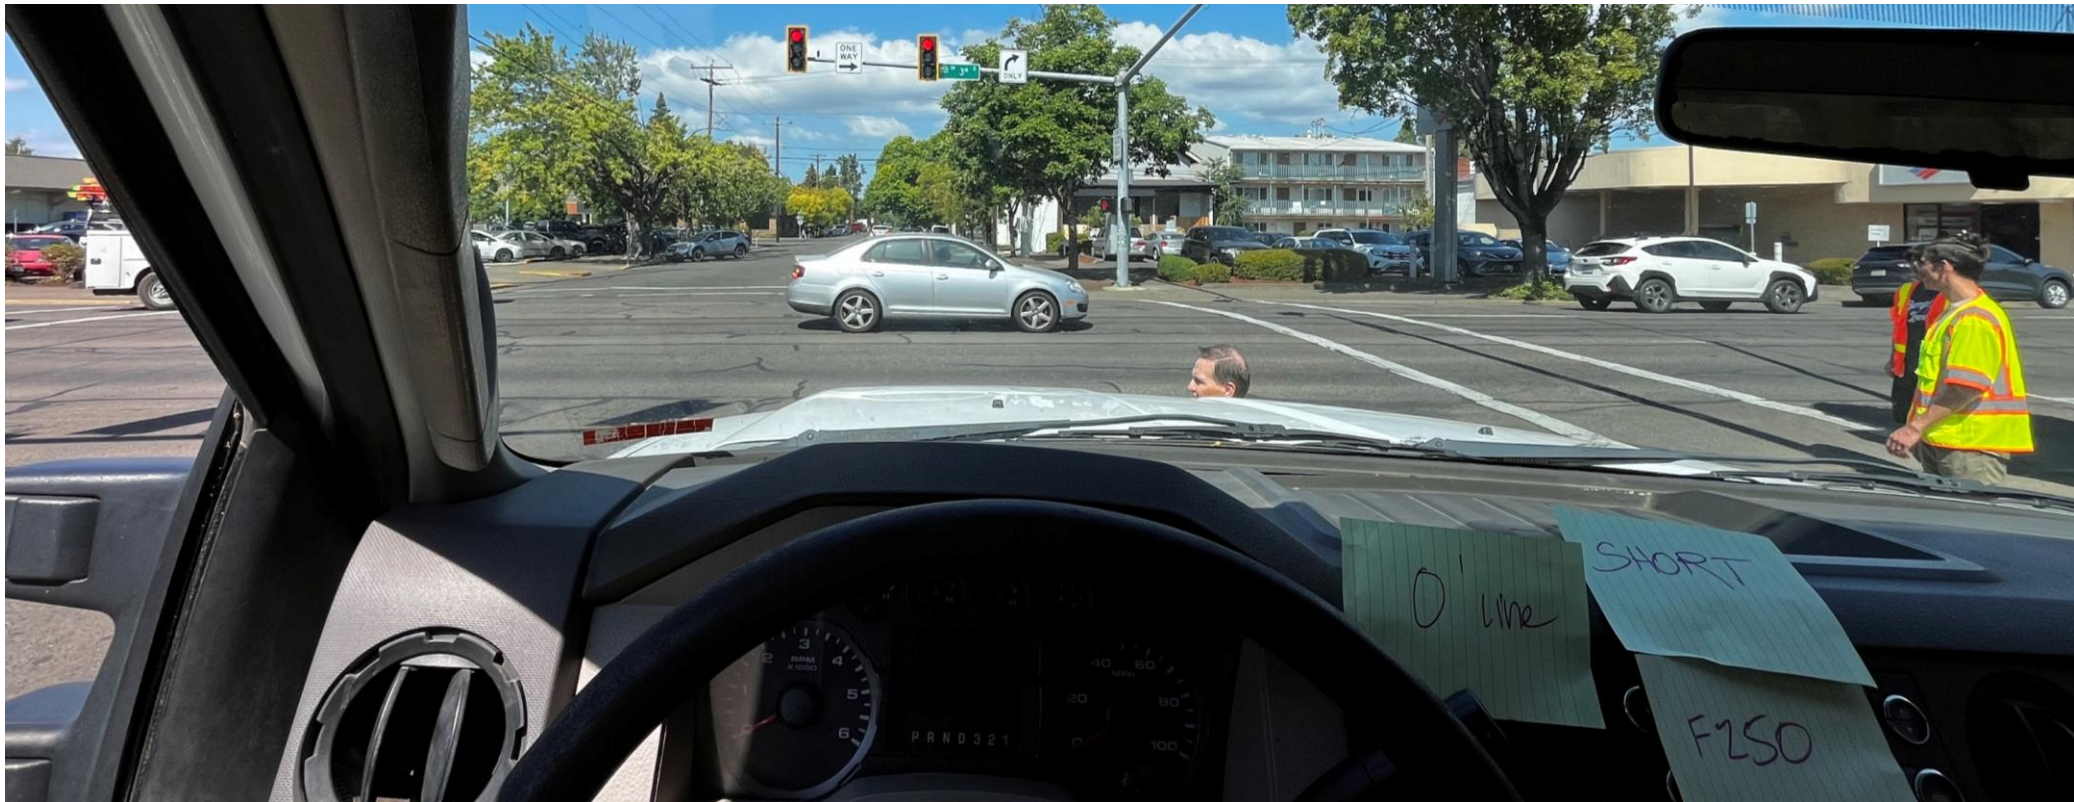
Pedestrian (esp. wheelchair/child) + Crosswalk + High Hood = Very Low/No Visibility

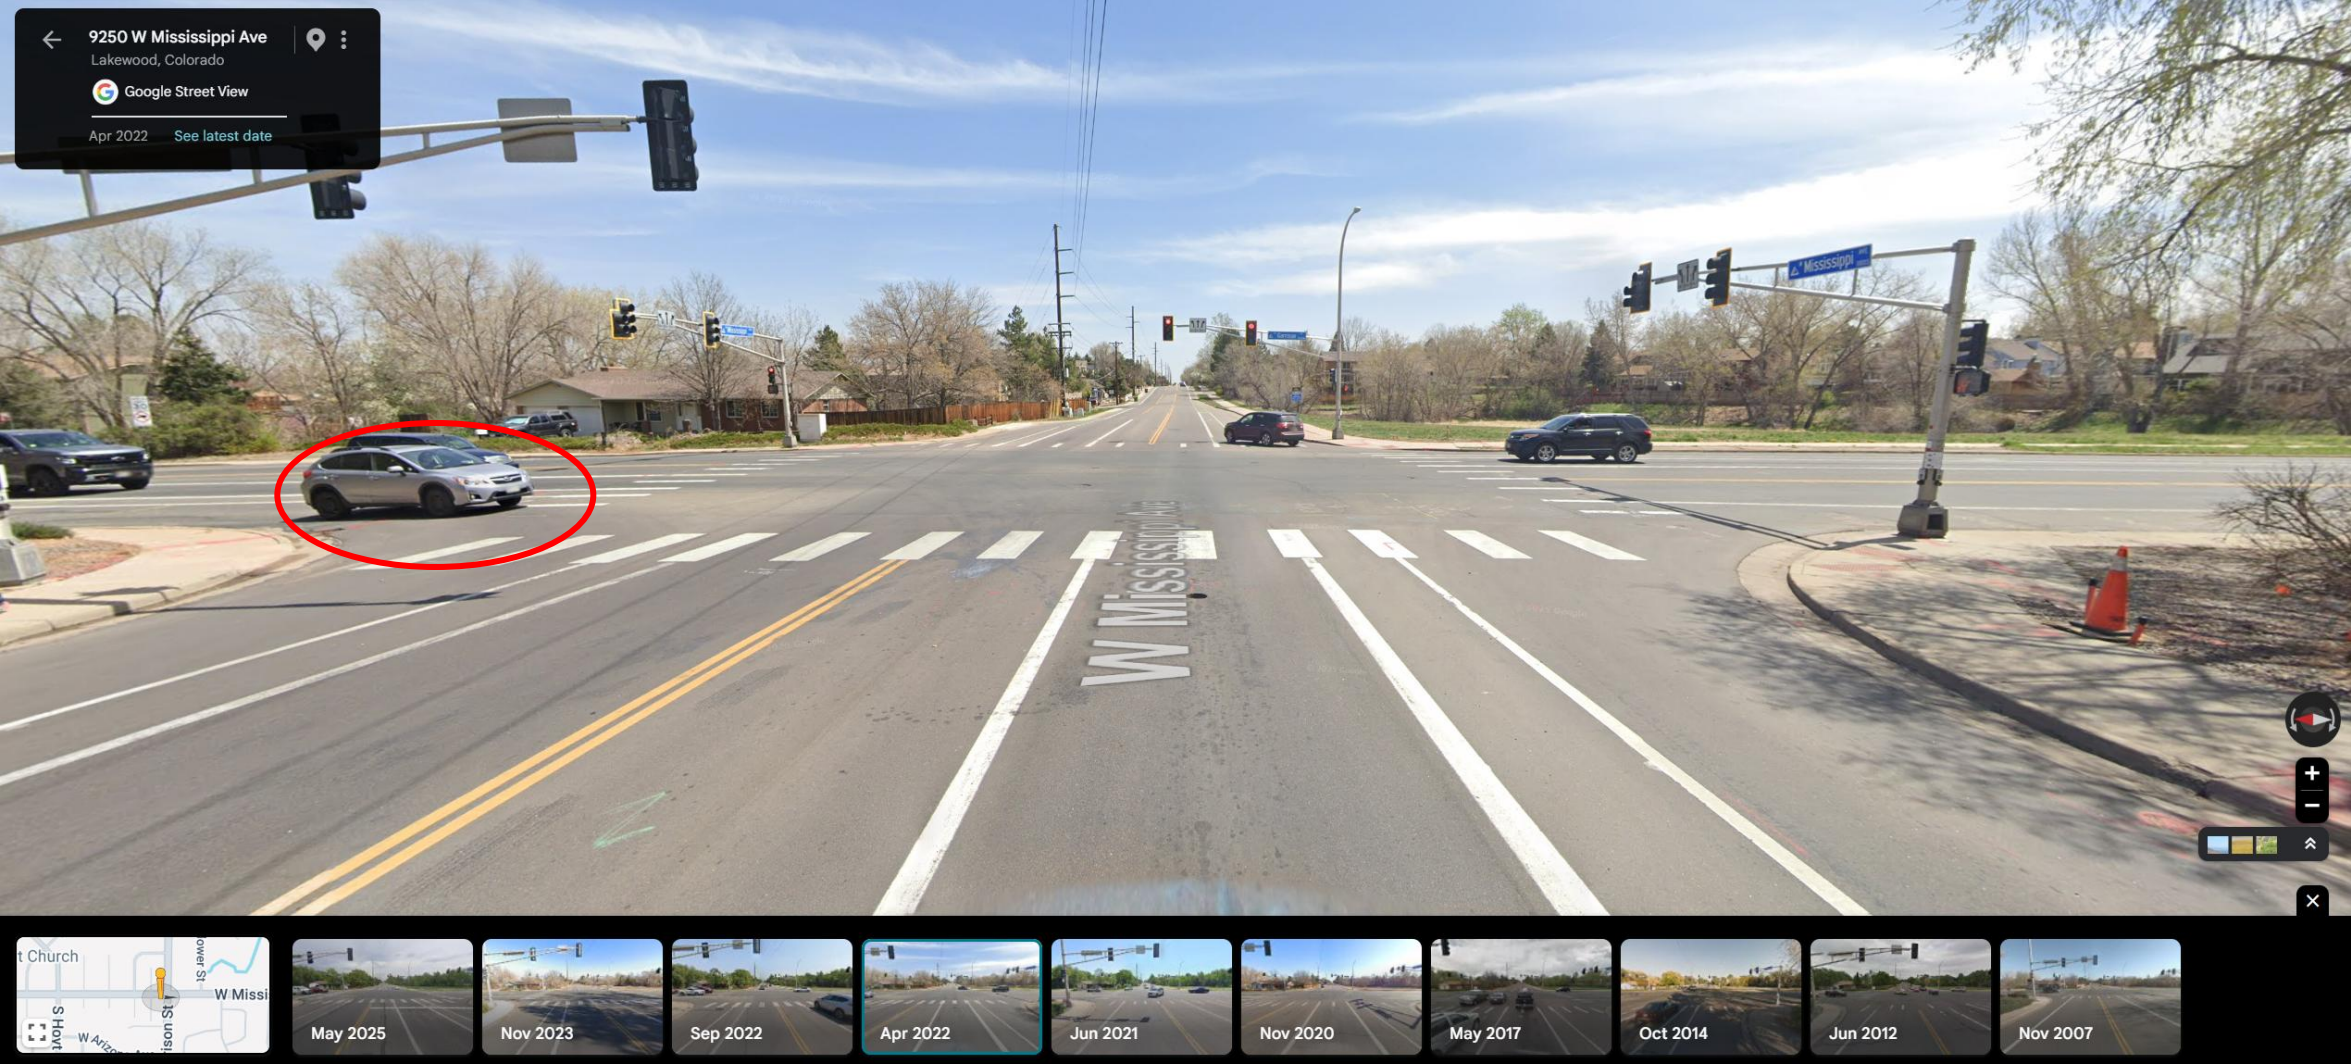
W Mississippi Ave & S Garrison St

# Pre 2024/2025

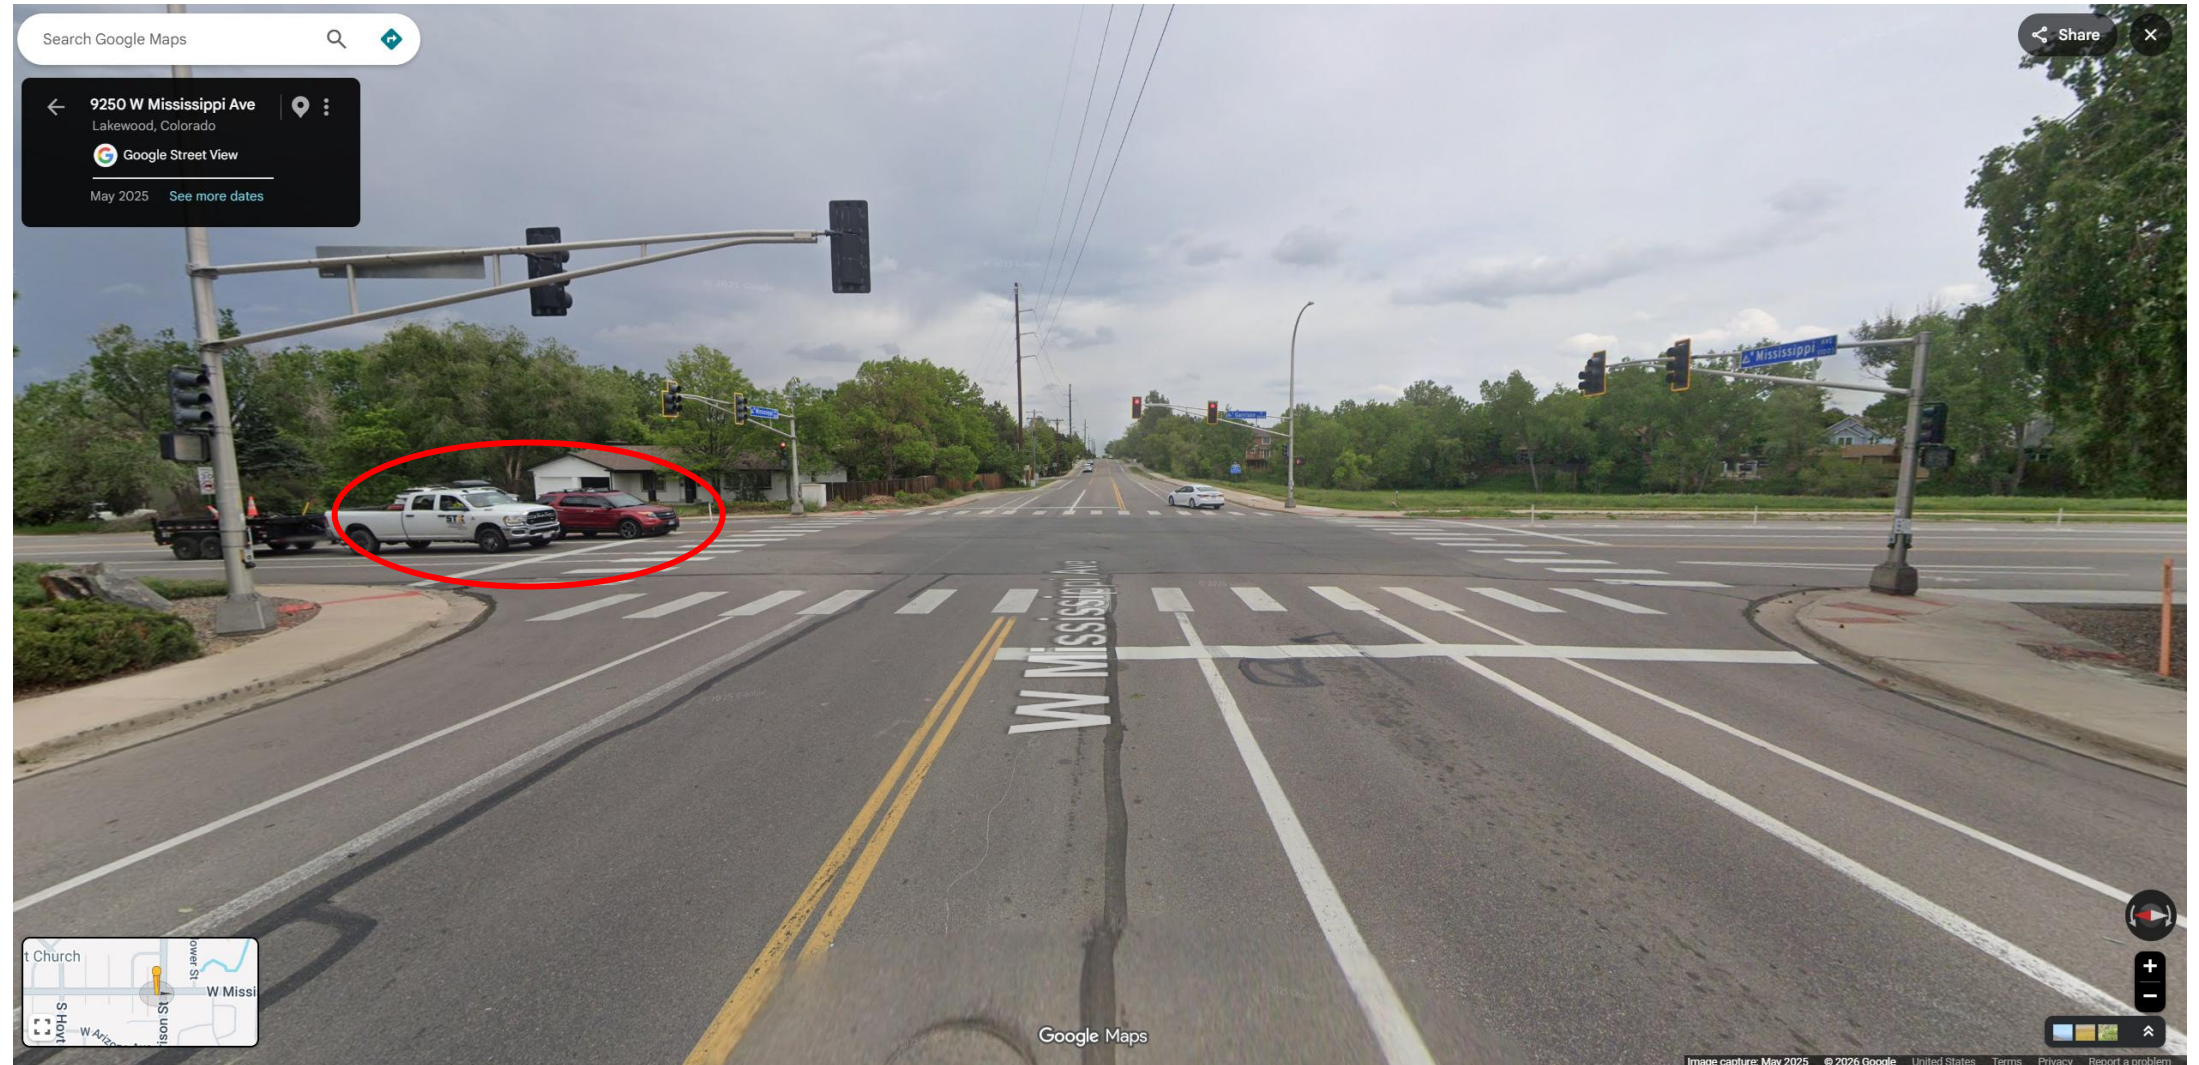
W Mississippi Ave & S Garrison St

8-ft advance stop lines

# Post 2024/2025

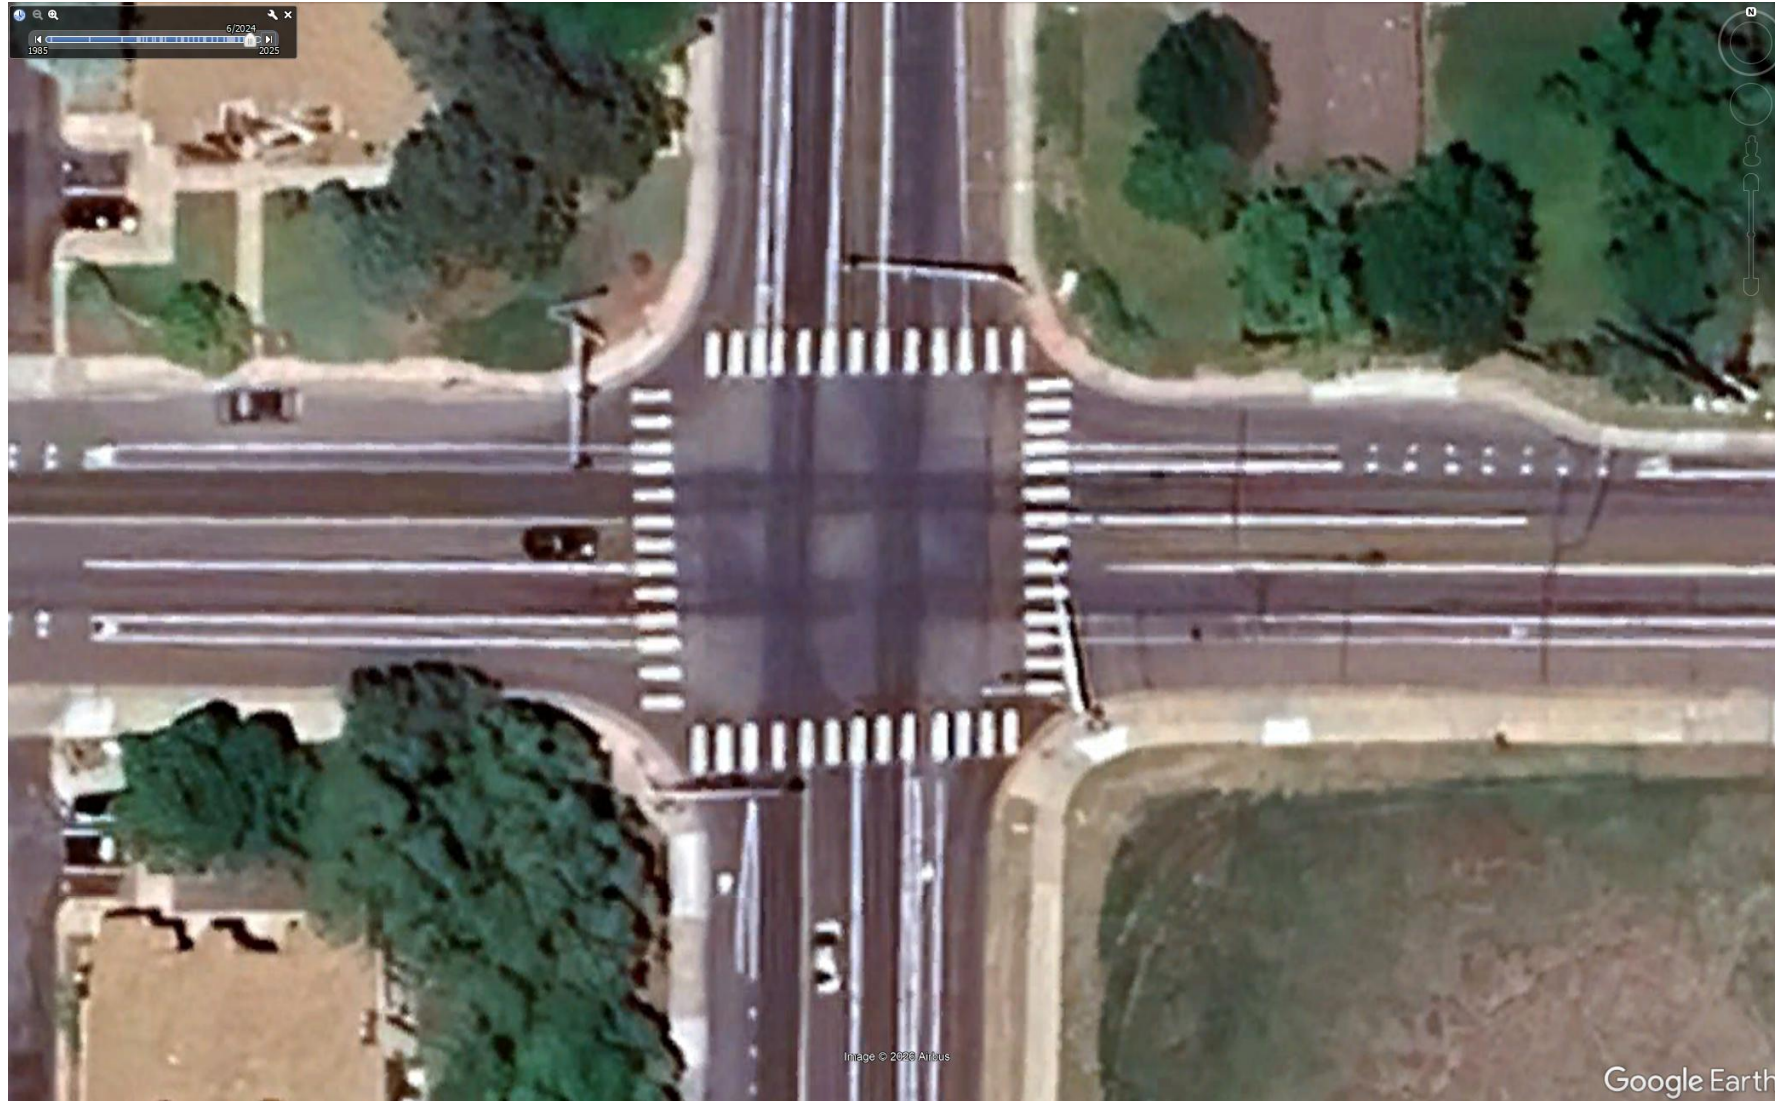
W Mississippi Ave & S Garrison St

# Pre 2024/2025

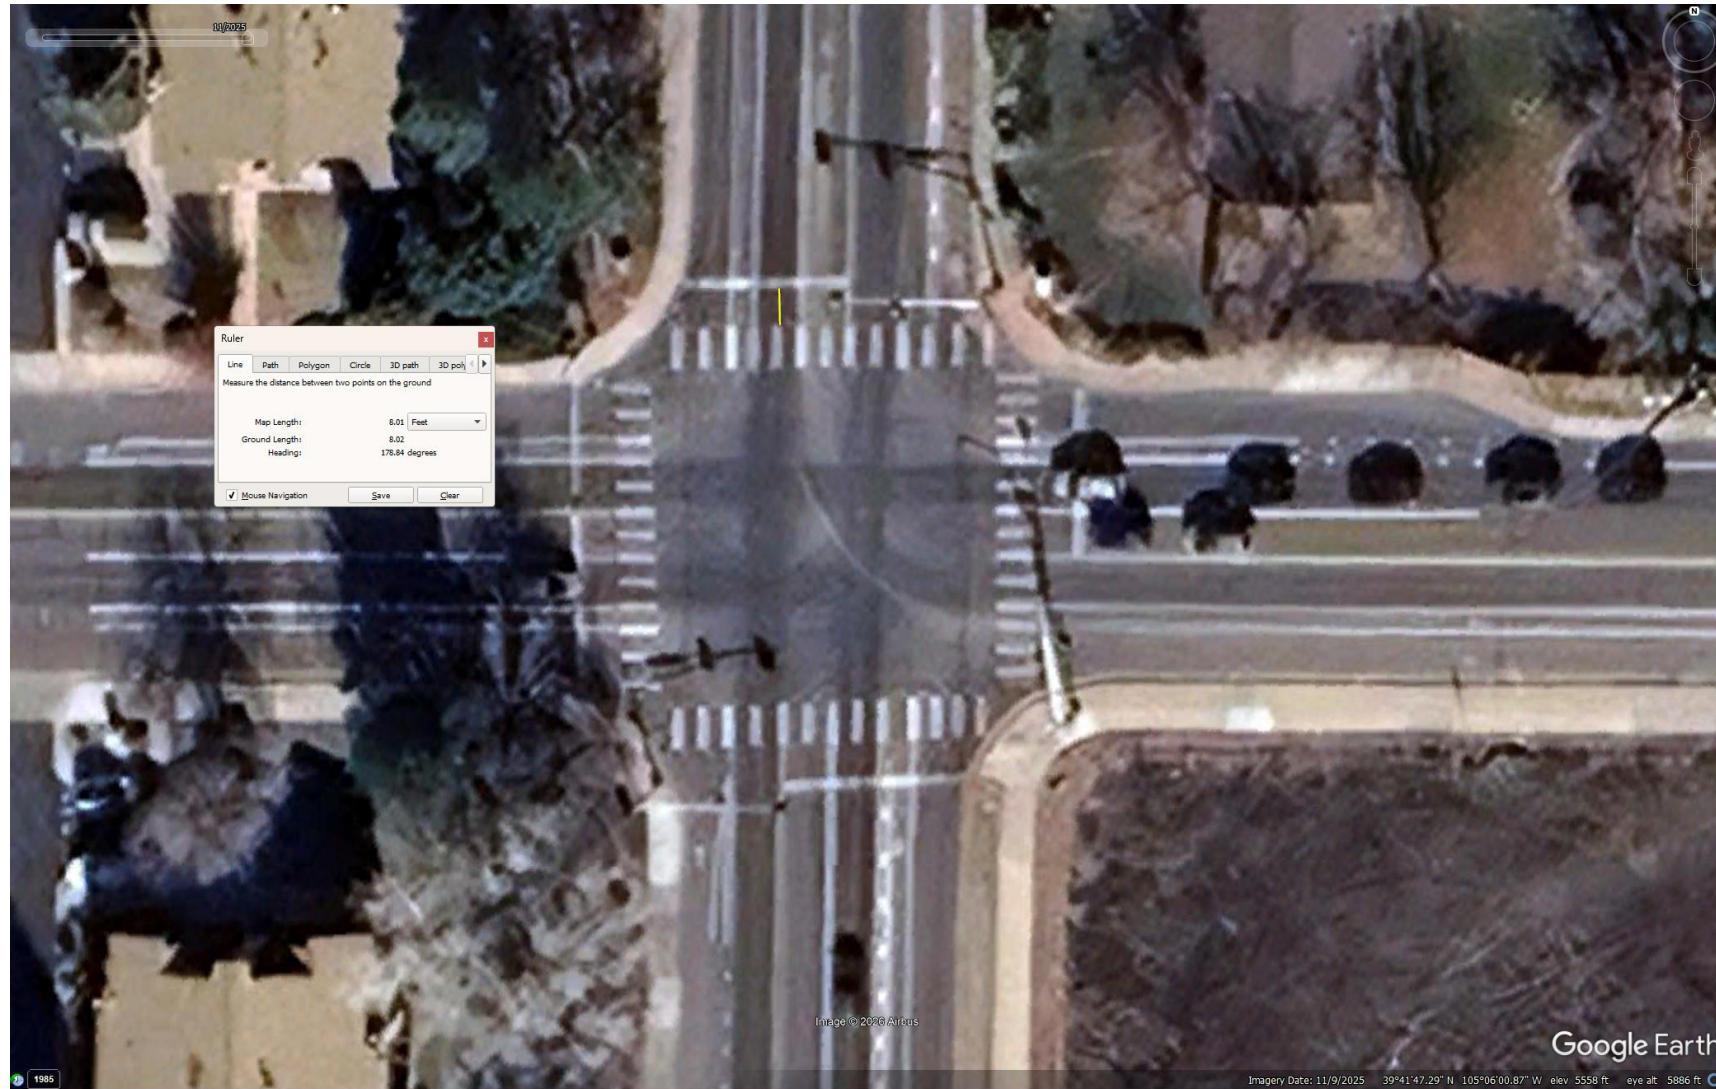
W Mississippi Ave & S Garrison St

# Post 2024/2025
